ASIA **TURBOMACHINERY & PUMP** SYMPOSIUM
MARCH 2018 | SUNTEC | SINGAPORE

Emerging Failures in Gas Turbine Engines Operating in Hot Environments

Two (2) gas turbine engines operating offshore experienced Domestic Object Damage (DOD) failure with damaged blades in the HP compressor section.

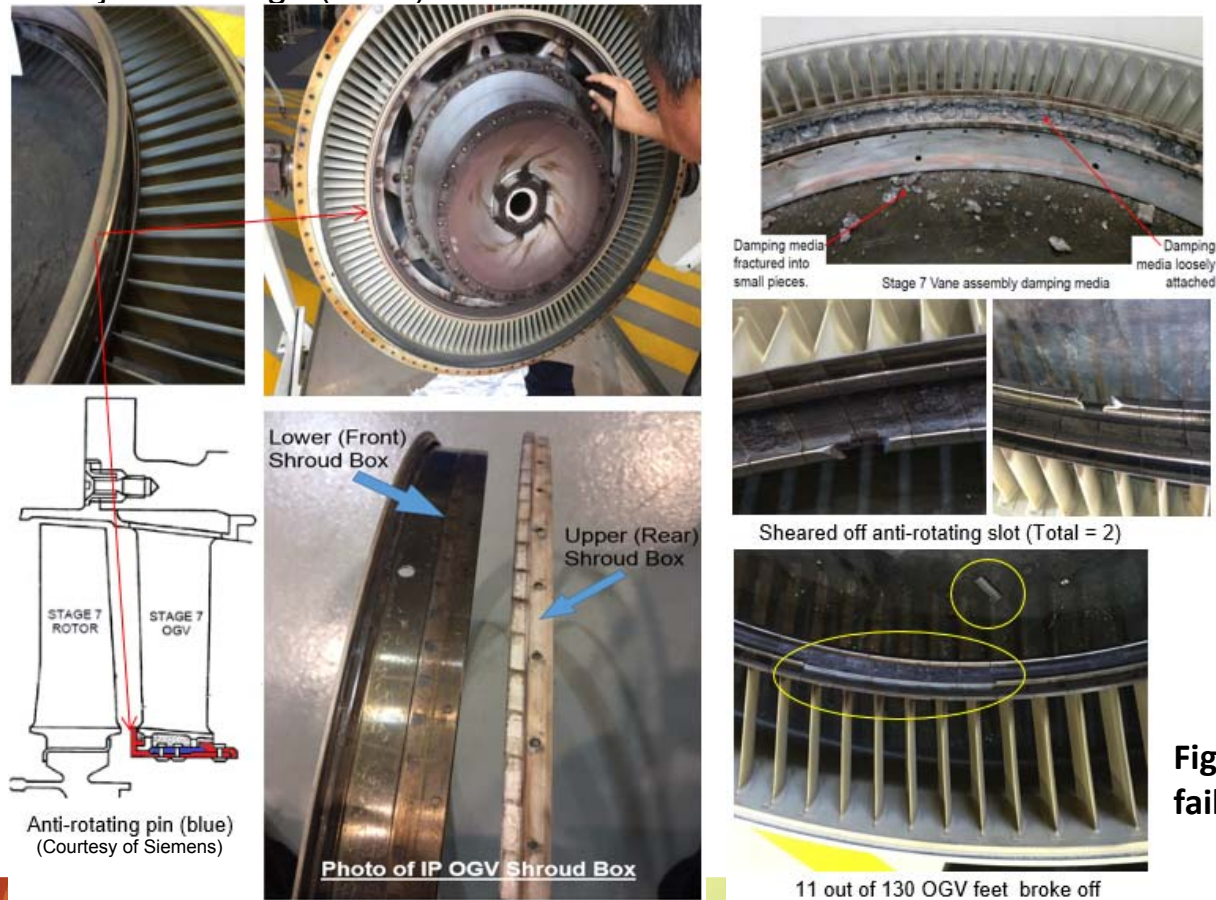
Fig 3: Images from first failed DOD engine

Engine 1: IP OGV Damping media breakdown combined with shroud box wear leading to OGV failure resulting in engine Domestic Object Damage (DOD).

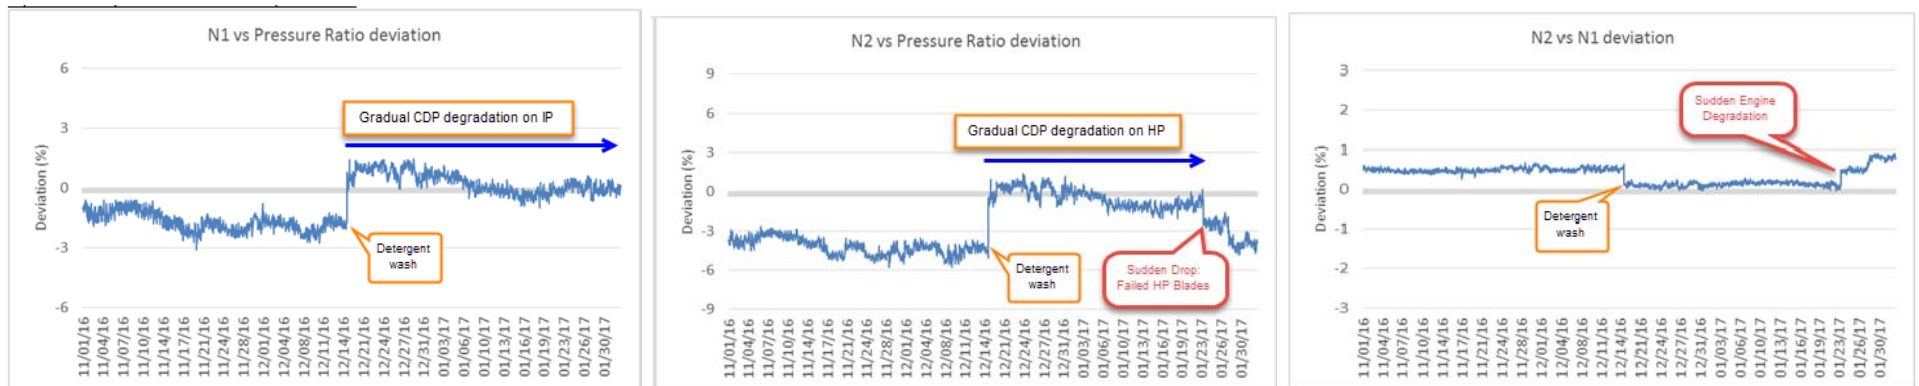
Fig 4: Surveillance trends from second failed DOD engine

1. Using trends from first failure, algorithms were developed for online Equipment Health Monitoring (EHM) early detection.
2. This was triggered on a second engine when GG performance started to deteriorate beginning **23rd Jan 2017** per below.
3. The IP compressor trends indicated normal deterioration but the HP compressor showed rapid performance deterioration.

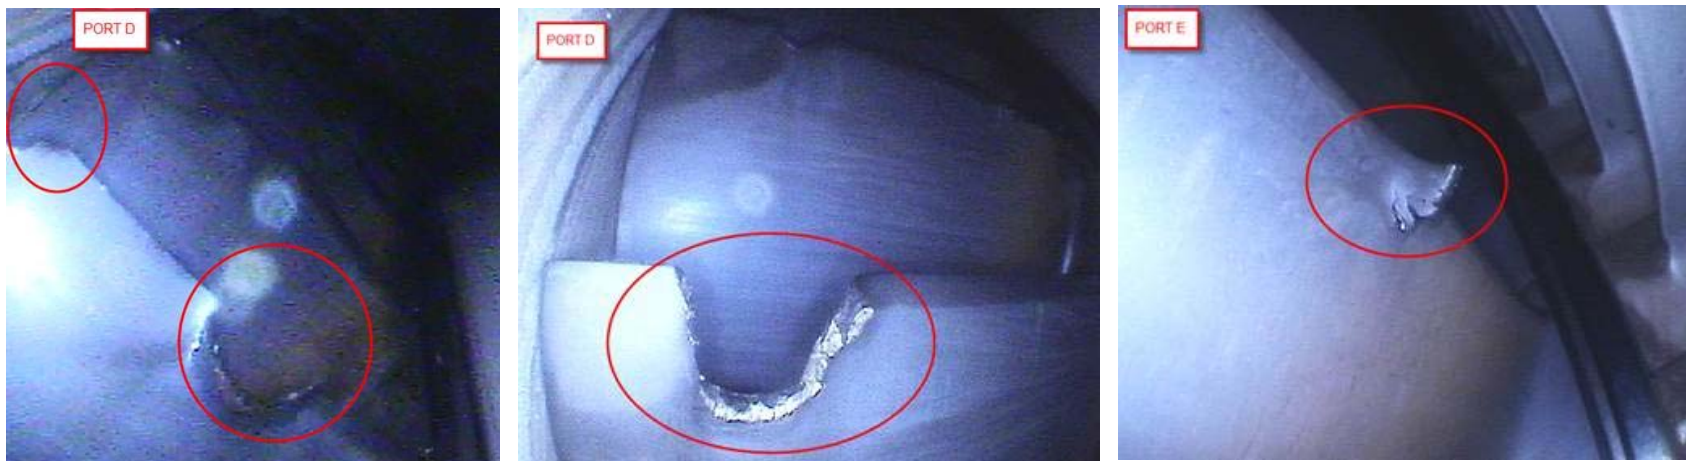
Fig 5: Boroscope images showing damaged HPC blades

4. Engine boroscope performed subsequent to **EHM** notification confirmed HPC blade damage.

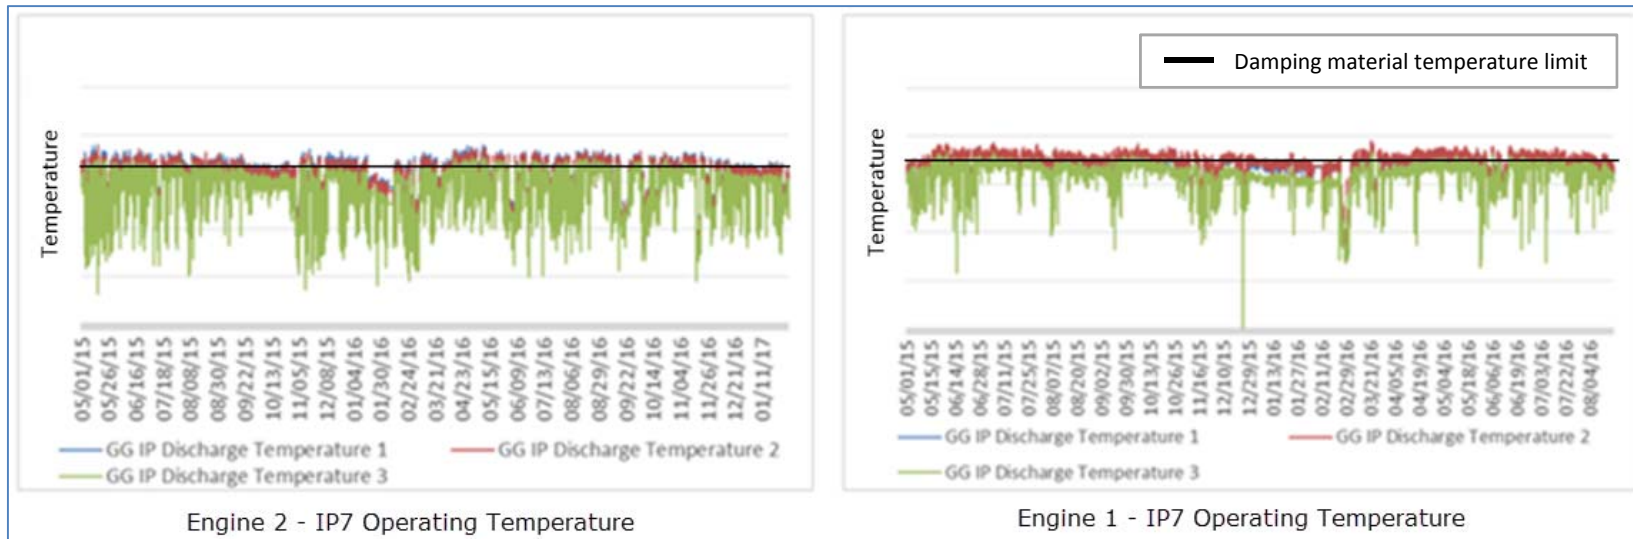
Fig 6: Temperature trending at IP OGV area for both failed DOD engines

Engine IP discharge temperature (IP7) trends showed that discharge temperature for both failed engine exceeded the working temperature threshold of the damping material.

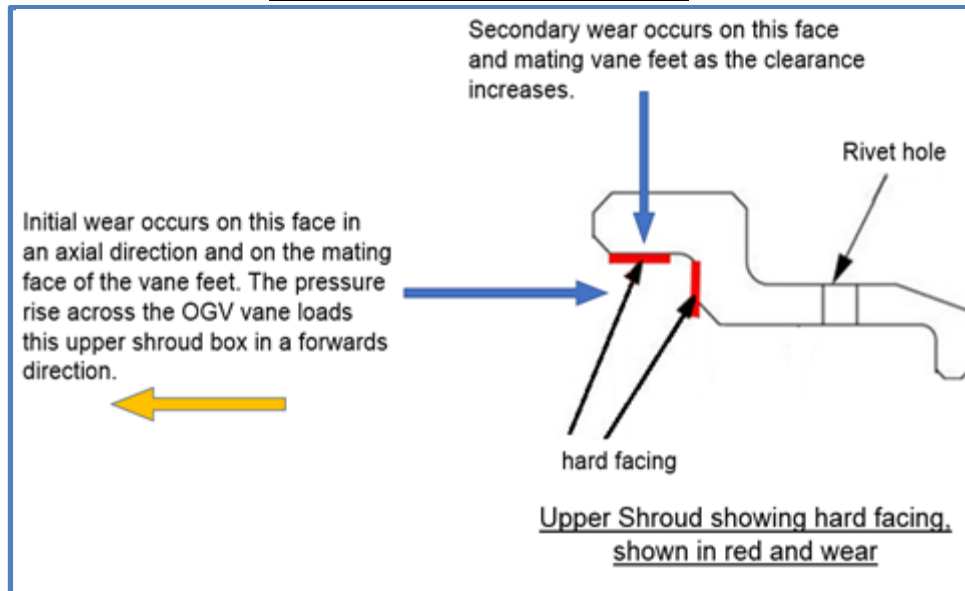
Fig 8: Wear areas on upper shroud box caused by rattling

- 3 If the clearance is greater than 'new' limits then rattling wear takes place. Proposed containment action prevents engine failure cycle at this point.

- 4 The wear progresses to the square of the clearance, with the shroud box moving forwards.
- 5 The rotational rattling movement of the shroud box wears through the anti-rotation strips or loosens its rivets until they fall out.

- The past acceptance standards for the shroud box could allow reuse of part with no hard coating remaining.
- Hence, OGVs are rebuilt to 'as new' limits. This will allow achieving the target life expectancy with least likelihood of an engine failure.
 - The vane feet are returned to new condition as there is a repair scheme to do this.
 - OEM has issued revised inspection limits for the shroud box, components with no hard coating are replaced.
- We have screened our engine fleet and identified high risk engines that require interim OGV change-out to prevent an unplanned engine failure.

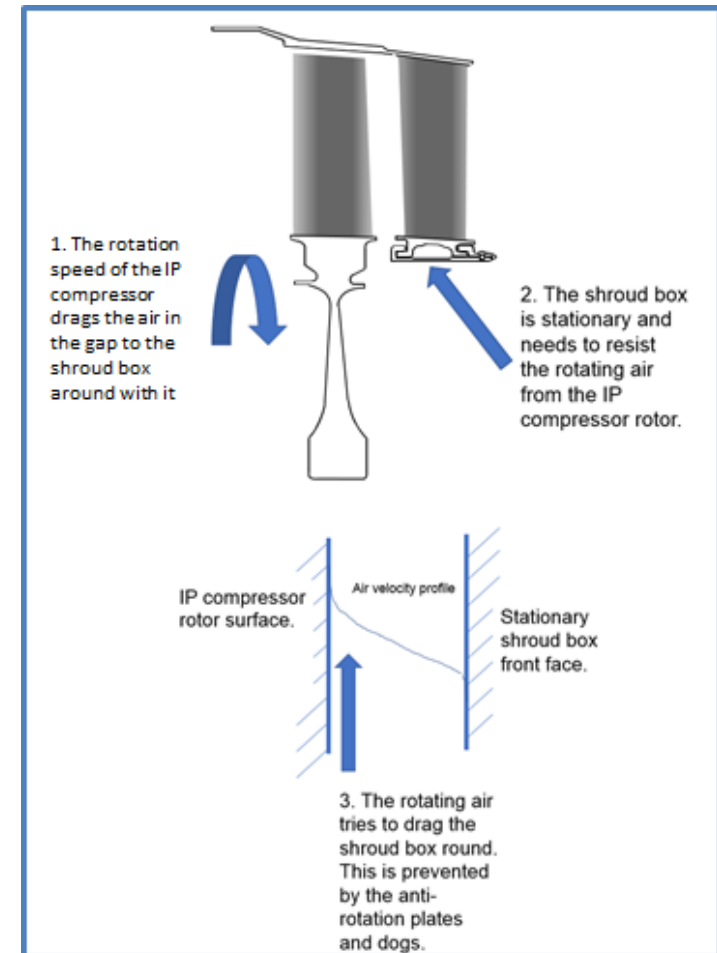
Fig 9: Rotational movement of shroud box

- 6 Eventually the shroud box is free to rotate increasing the wear. Finally the shroud box clearance is sufficient for it to contact the IP rotor.
- 7 Both conditions can rotate the shroud box, wearing through the vane feet and releasing debris into the gas stream causing Foreign Object Damage (FOD) to the HPC blades. The damage can continue until the actual shroud box itself breaks up causing severe engine DOD.

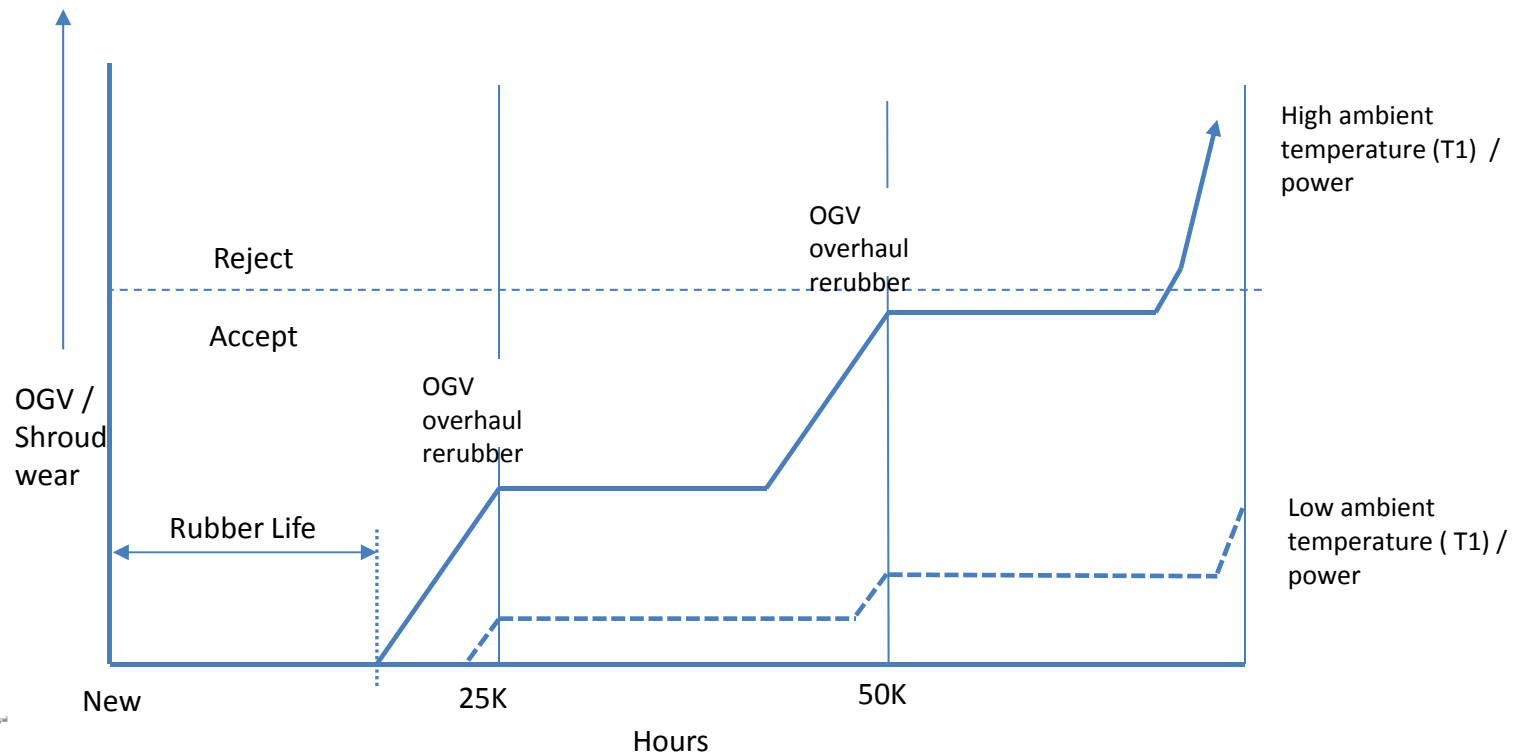
Fig 10: Wear on OGV shroud box against hours in operation and effect of ambient condition

Analysis of failed engines indicated **high ambient temperature environment** combined with **maximum power operation AND repeated use of shroud box** after engine overhauls contributed to the accelerated wear. The engine failure progression is as below:
